INSPECTION REPORT

XpertHomeInspectorLLC

**123 American Dream RD.
Inspection Prepared For: Wise Investor
Agent: Jenny Realtor - 80s Realty Company**

**Date of Inspection: 4/8/2026
Year Built: 1958 Size: 2169
Weather: Sunny**

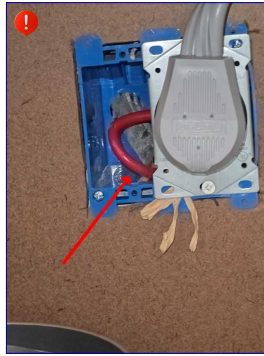
Page 42 Item: 8	Appliances	<ul style="list-style-type: none"> • The stove receptacle was located in a lower cabinet and was missing a protective cover. I recommend having cover installed for added safety.
-----------------	------------	--

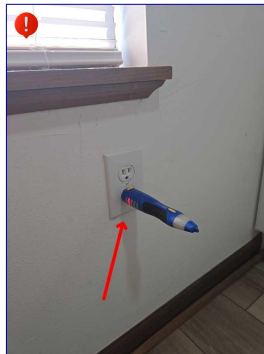
Page 47 Item: 8	Receptacles	<ul style="list-style-type: none">• GFCI receptacles are not installed within six feet of water in bathroom 2, which is a safety concern. However, at the time the home was built, installing GFCI receptacles were not part of the standard building requirements. Recommend upgrading the GFCI receptacles to current standards for increased safety.
-----------------	-------------	--

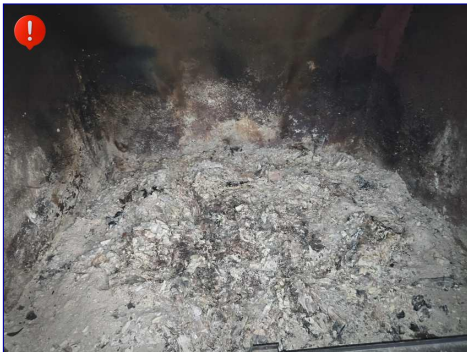
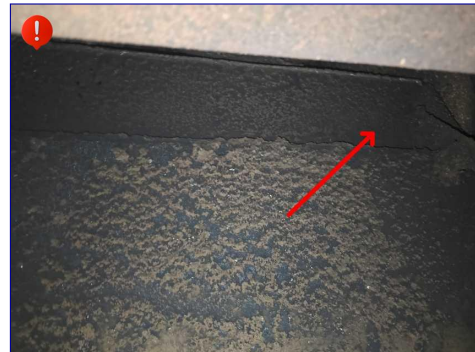
Page 54 Item: 6	Fireplace	<ul style="list-style-type: none">• There is soot built up in the fireplace flue. Potential safety hazard. Recommend a licensed chimney sweep clean and examine the fireplace flue.
-----------------	-----------	---

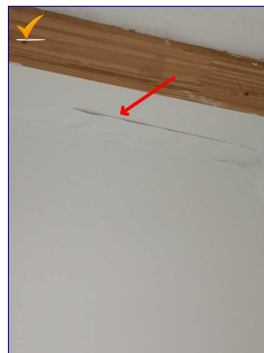
• The home had a few areas where the tape joists are coming loose. I recommend having evaluated and repaired.

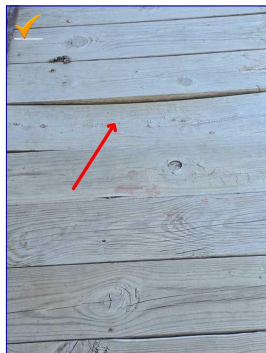
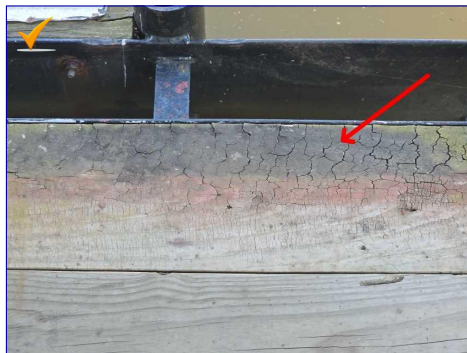
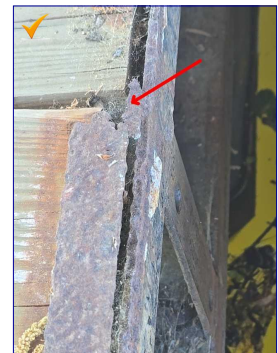
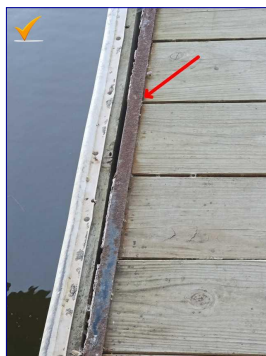
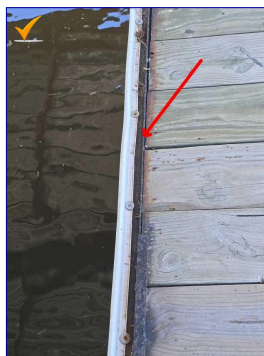
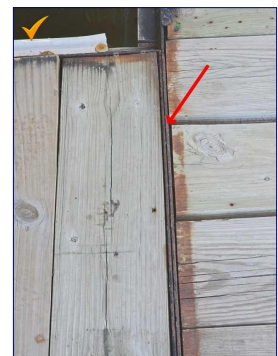
- The decking boards on the dock had signs of aging. There were warped boards, minor moisture damage, and rust on portions of the metal dock frame. I recommend having evaluated and repaired by a licensed dock contractor.

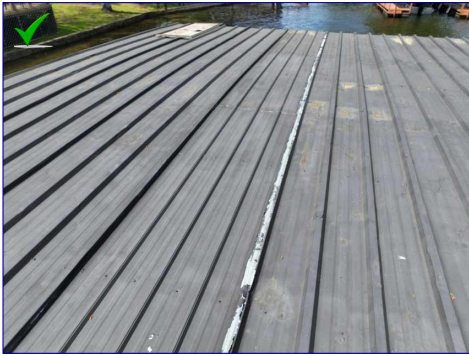
- The boat dock roof had damage and has been patched several times. I recommend having a licensed roofer evaluate and make repairs before closing. Contact entergy shoreline for permitting.

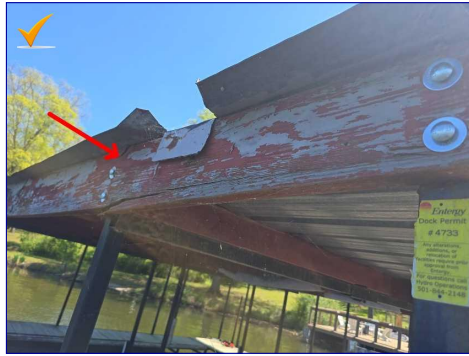
- The wood on the dock had peeling paint and deferred maintenance. I recommend having evaluated and repaired before closing.

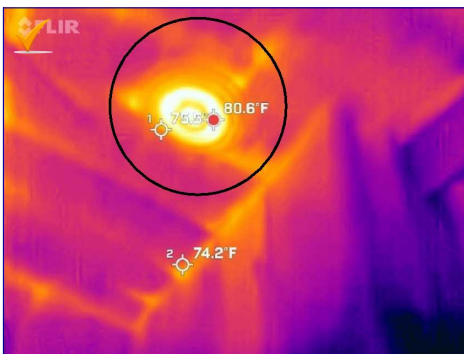
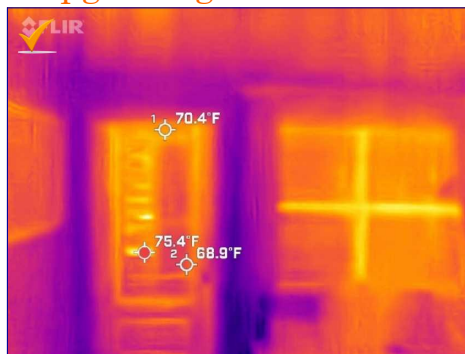
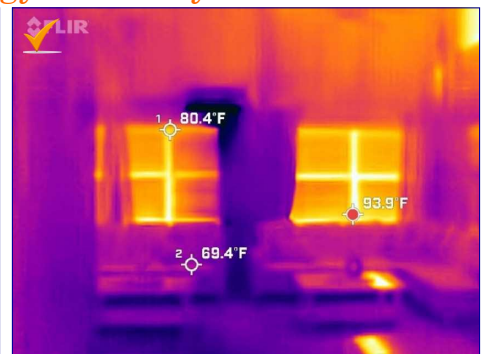
- The windows were single pane metal windows. These are considered to be outdated. The thermal scans showed heat signatures around all the windows. I recommend upgrading for better energy efficiency.

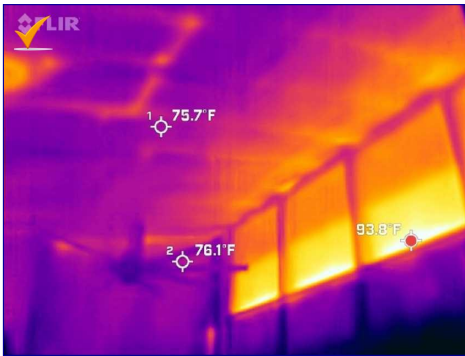
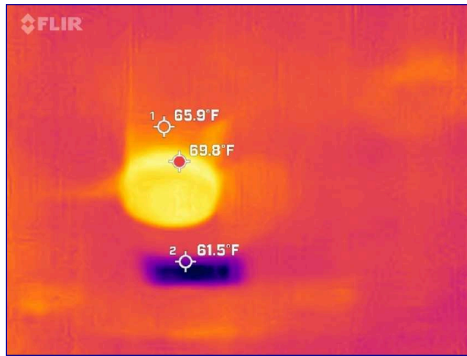
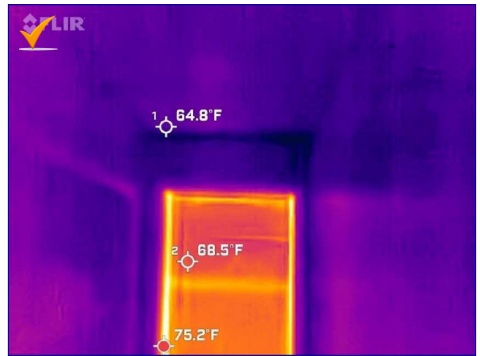
There is a metal plate installed in the living room ceiling. This is allowing heat to transfer into home. I recommend repair to help be more energy efficient.

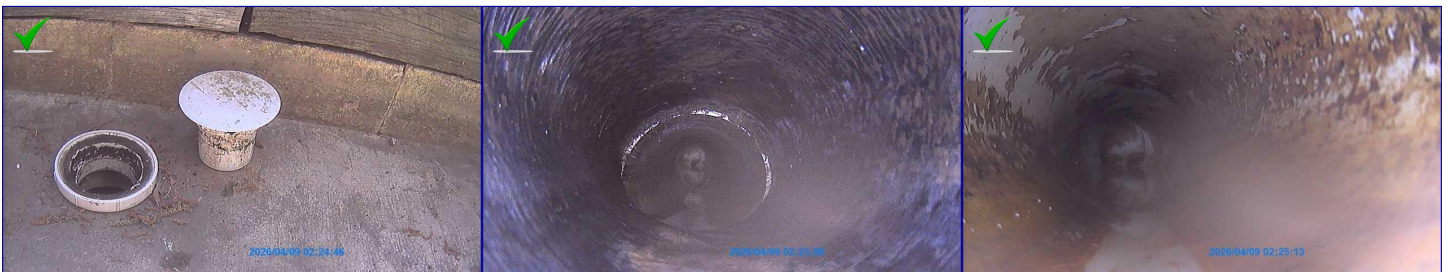
• A sewer camera inspection of the accessible drain line was performed at the time of inspection. The system is configured with PVC piping from the cleanout toward the sewer holding tank and cast iron piping from the cleanout toward the home.

The PVC section appeared generally smooth-walled and in functional condition at the time of inspection, with no significant defects observed in the visible portions.

The cast iron section, however, exhibited moderate to heavy internal corrosion, scaling, and buildup along the pipe walls. In several areas, this buildup is substantial enough to reduce the effective diameter of the pipe, which can impede proper wastewater flow. Organic material and debris were observed adhering to the interior surfaces, consistent with aging cast iron piping.

These conditions are considered deficient and increase the likelihood of:

Recurring blockages or slow drainage

Wastewater backup into the home

Progressive deterioration and eventual failure of the pipe

It is recommended that the cast iron portion of the drain line be evaluated by a licensed plumber or sewer specialist. Cleaning (such as hydro-jetting) may provide temporary improvement; however, due to the level of corrosion and buildup observed, repair or replacement of the cast iron piping should be anticipated.

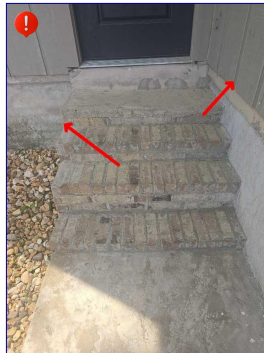
Page 26 Item: 3	Steps/Stoop	<ul style="list-style-type: none"> • There are one or more missing railings on the exterior steps. This presents a potential fall concern. Recommend a licensed contractor install proper railings.
-----------------	-------------	--

- There are one or more missing railings on the exterior steps. This presents a potential fall concern. Recommend a licensed contractor install proper railings.

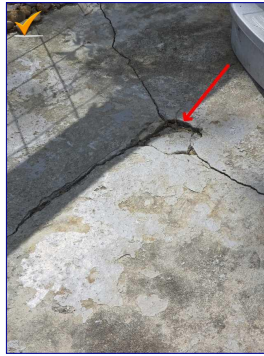
- The patio had some cracking and settlement but was in usable condition. Repair as needed.

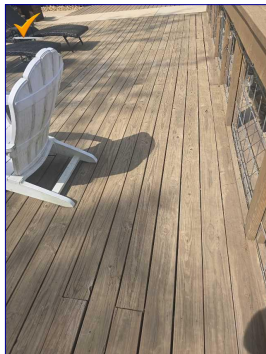
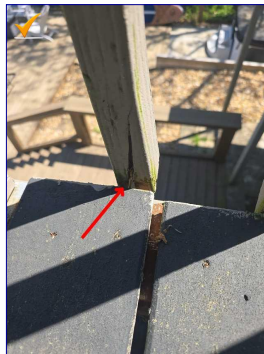
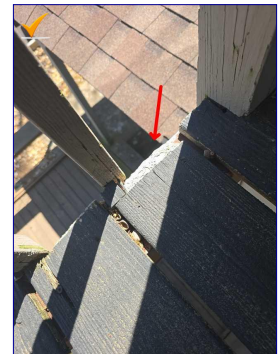
- The wood in the deck needs painting or treating. Recommend painting or treating wood on the deck to help protect it from damage.
- There are areas of rot/moisture damage beginning on the deck. Rot will shorten the life of the deck. Recommend removing/treating the rotted areas. A licensed contractor should replace any damaged wood as needed.

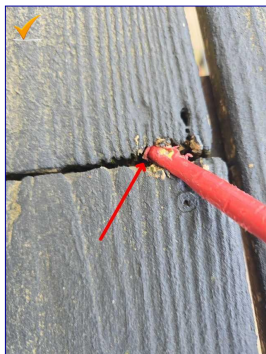
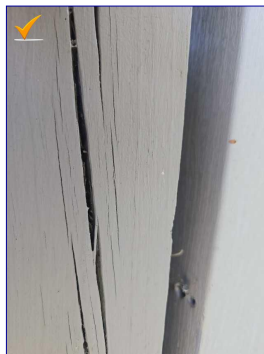
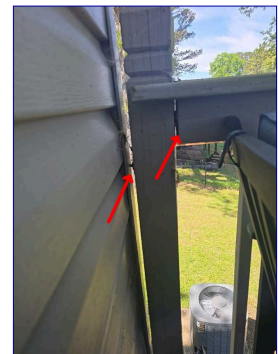
The deck has normal age-related wear. I recommend budgeting for repairs in the near future.

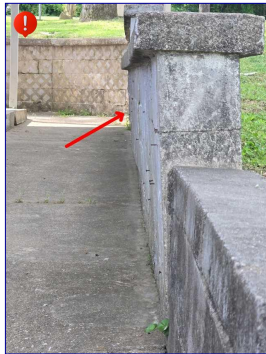
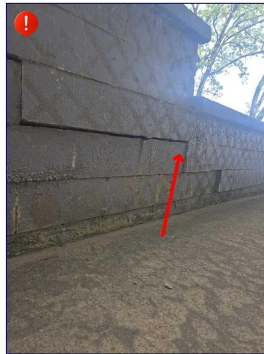
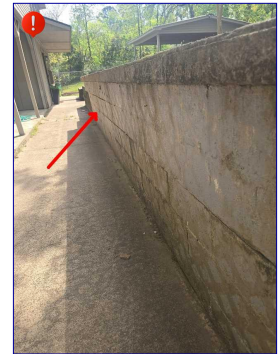
- The retaining wall is leaning and becoming unstable. Recommend a professional contractor repair.

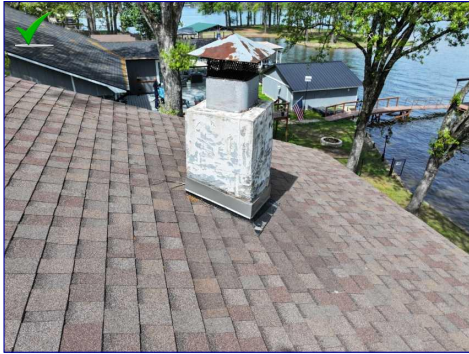
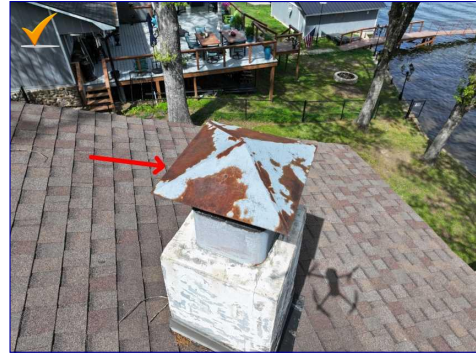
- The chimney cap is rusted. Monitor and consult a licensed chimney sweep as needed.

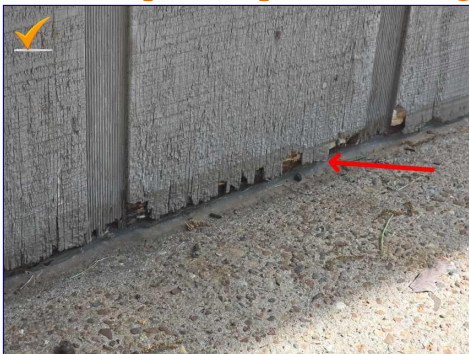
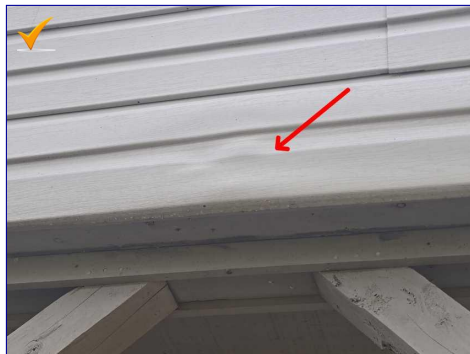
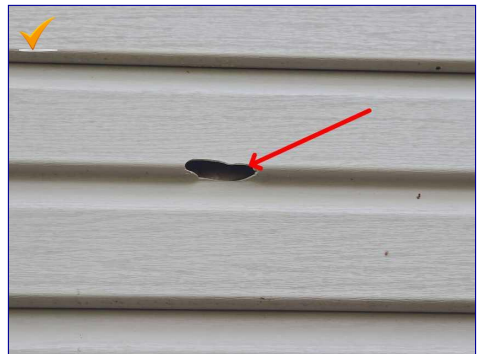
- The siding had some damage, recommend a licensed contractor repair/replace damaged sections.

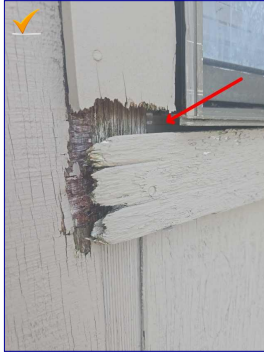
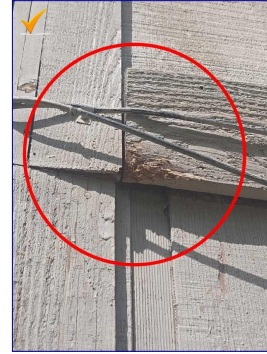
- Some of the trim was damaged. Recommend repair or replacement of damaged exterior trim by a licensed contractor.

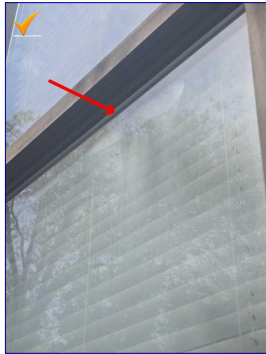
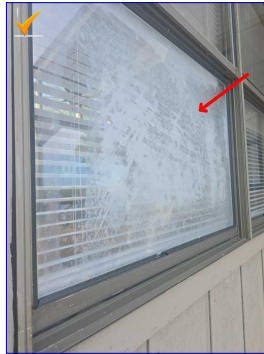
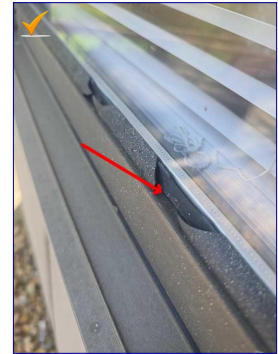
- There is evidence of damaged insulated glass in one or more windows, which will make the windows less efficient, and the seal will fail over time. Monitor and consult a professional contractor for repair or replacement of affected window(s).

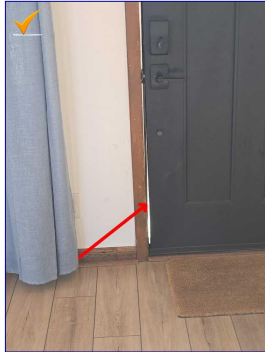
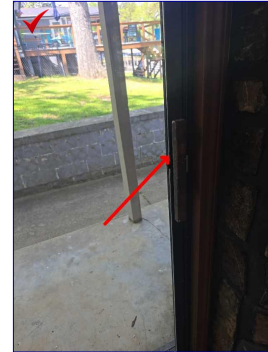
- The side sliding patio door did not work. I recommend having repaired as needed for proper operation.

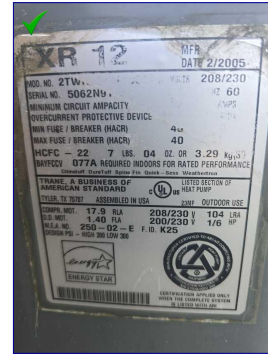
- Please note; the cooling system contains R-22 refrigerant (Freon). By EPA Standards, this Freon will be phased out starting in 2020. Accordingly, when the air conditioner requires repair to the "closed refrigerant system," the R-22 refrigerant may need to be removed. R-22 may be added to the system if available, or a retrofit option may be available. We recommend saving for repairs and replacement. Consult a licensed HVAC contractor as needed.

The air conditioner compressor/condenser data plate. 2005 year. Appears to be a 3 ton unit.

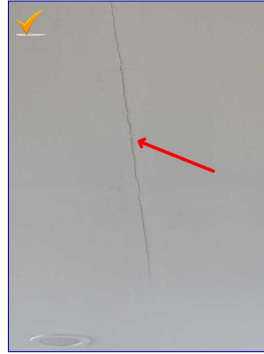
There are typical cracks on the walls/ceilings. Monitor and repair as needed.

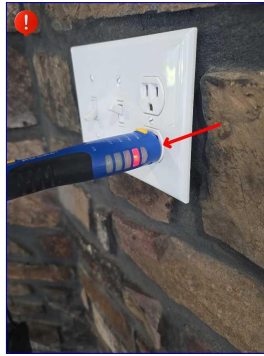
- Open ground exists at the receptacles in the dining room, which is a safety hazard. Recommend a licensed electrician repair.

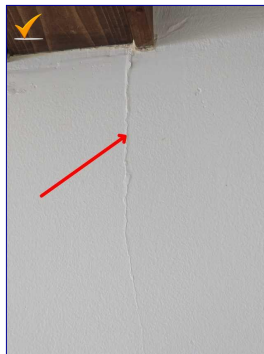
- **Typical cracking present in the kitchen walls/ceiling. Recommend monitoring and repair as needed.**

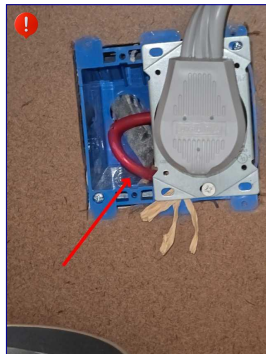
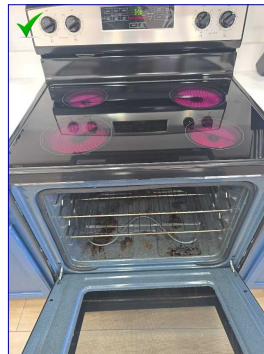
• The stove receptacle was located in a lower cabinet and was missing a protective cover. I recommend having cover installed for added safety.

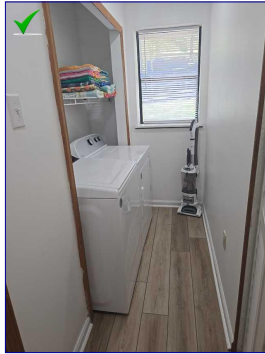
- The door for laundry room was not installed. I recommend installing a proper door.

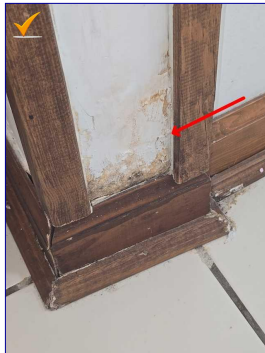
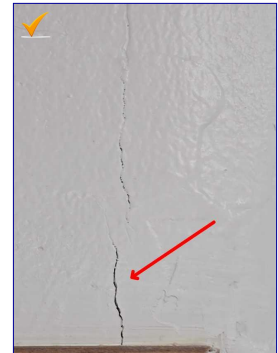
• The lower portion of the bathroom walls had signs of moisture staining. I recommend having evaluated and repaired.

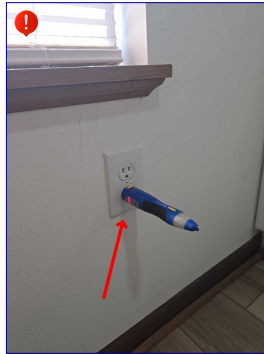
• GFCI receptacles are not installed within six feet of water in bathroom 2, which is a safety concern. However, at the time the home was built, installing GFCI receptacles were not part of the standard building requirements. Recommend upgrading the GFCI receptacles to current standards for increased safety.

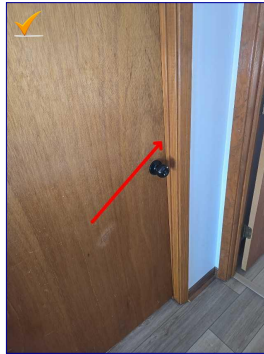
- The bedroom door would not latch properly. Recommend a professional contractor repair or adjust as needed.

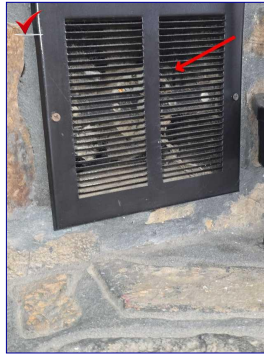
- The fireplace chimney damper does not operate. Recommend a licensed chimney sweep repair.
- The fireplace built-in blower fan was not operational. Recommend a professional fireplace technician evaluation and repair.

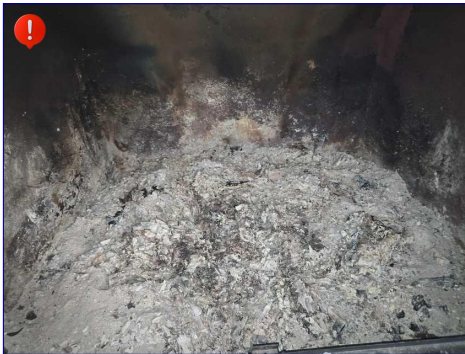
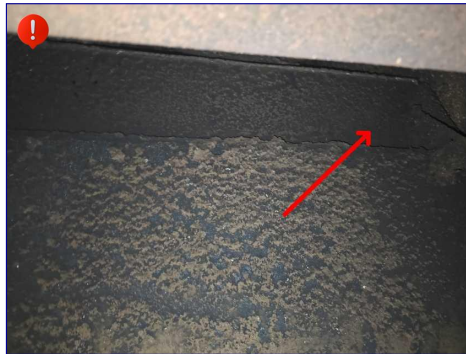
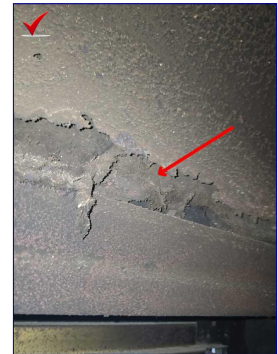
- There is soot built up in the fireplace flue. Potential safety hazard. Recommend a licensed chimney sweep clean and examine the fireplace flue.

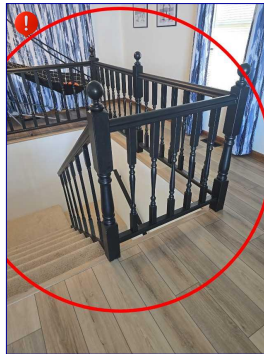
Page 55 Item: 1	Stairs, Steps, Hallways	<ul style="list-style-type: none"> • The handrail is loose to the second floor, which is a potential safety hazard. Recommend securing/repair.

- The handrail is loose to the second floor, which is a potential safety hazard. Recommend securing/repair.

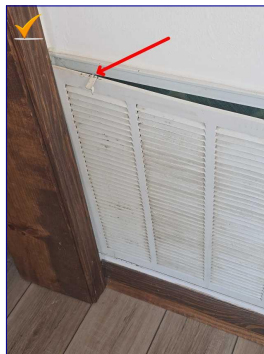
The filter grate door would not open due to hitting the trim. I recommend having repaired as needed for proper operation.

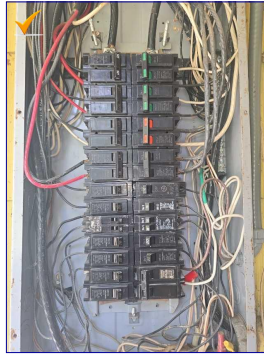
Sub-Panel View

• The electrical panel is a Challenger brand panel, which is considered obsolete and has a known history of breaker reliability concerns. Multiple deficiencies were observed, including double-tapped breakers, mixed breaker types, and disorganized wiring within the panel. Due to the age, condition, and known concerns associated with this equipment, evaluation by a licensed electrician is recommended. Panel replacement should be considered for improved safety and reliability.

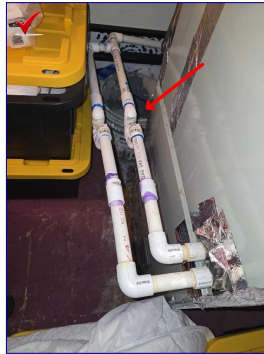
• There is no secondary condensate protection installed on the air conditioner evaporator coil drain. This is a common practice, however, we recommend a licensed HVAC contractor install a secondary protection switch to help prevent damage to the furnace in the event that the drain becomes clogged and overflows.
