XPERT HOME INSPECTOR

**1234 Sample easy st.
Inspection Prepared For: Larry Johnson
Agent: Zubberson SallyMae - Real Estate Express**

**Date of Inspection: 10/24/2022
Year Built: 2016 Size: 2810
Weather: Sunny**

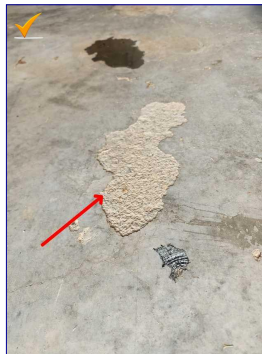
Page 14 Item: 4 | Floor

There was a small area of garage floor with spalling. Recommend licensed contractor to repair to prevent further future damage.

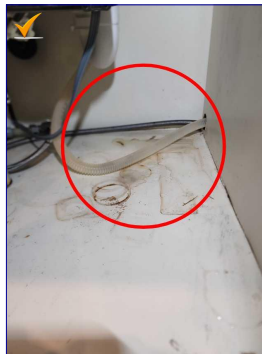
Page 17 Item: 1 | Plumbing

There was a small puddle of water under kitchen sink cabinet. The leak location was not determined. I recommend further evaluation and repair by licensed plumber.

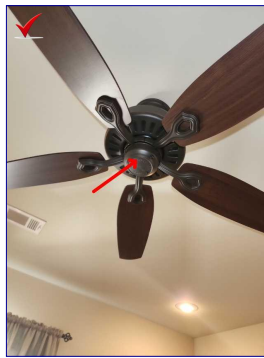
Page 25 Item: 4 | Ceiling Fan

• *The ceiling fan in the bedroom was not operational when tested. Recommend a licensed electrician evaluate and repair or replace as needed.*

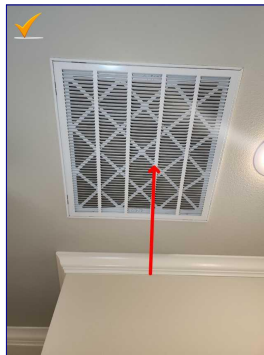
Page 34 Item: 5 | Filter

The furnace filter is dirty. Recommend changing the filter per the manufacturer's recommendations.

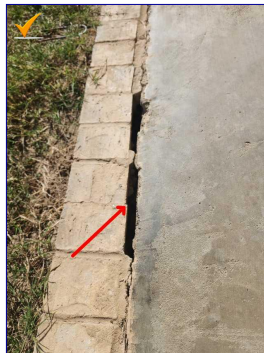
3. Patio

The mortar between brick and patio concrete had an area missing. Recommend repair to prevent future damage.

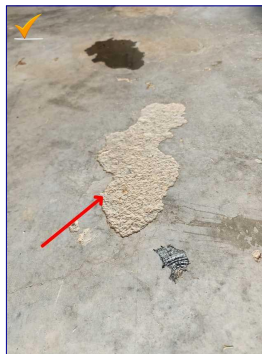
4. Floor

There was a small area of garage floor with spalling. Recommend licensed contractor to repair to prevent further future damage.

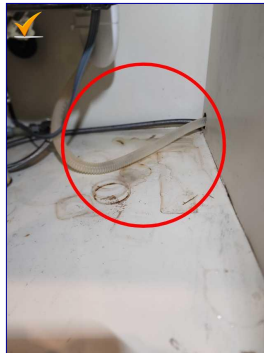
1. Plumbing

There was a small puddle of water under kitchen sink cabinet. The leak location was not determined. I recommend further evaluation and repair by licensed plumber.

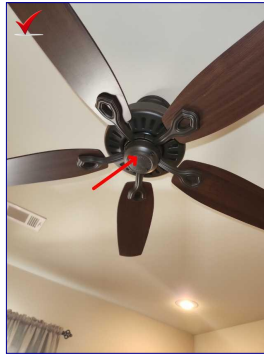
4. Ceiling Fan

- *The ceiling fan in the bedroom was not operational when tested. Recommend a licensed electrician evaluate and repair or replace as needed.*

- Recommend repair/replace

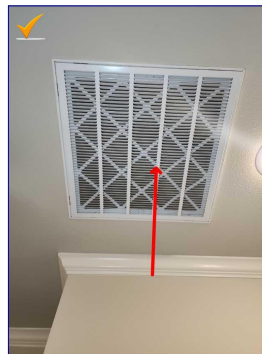
5. Filter

- Filter:
- Standard
 - Needs cleaning/replacement

The furnace filter is dirty. Recommend changing the filter per the manufacturer's recommendations.
