INSPECTION REPORT

XpertHomeInspectorLLC

**123 American Dream RD.
Inspection Prepared For: Wise Investor
Agent: Jenny Realtor - 80s Realty Company**

**Date of Inspection: 4/8/2026
Year Built: 1958 Size: 2169
Weather: Sunny**

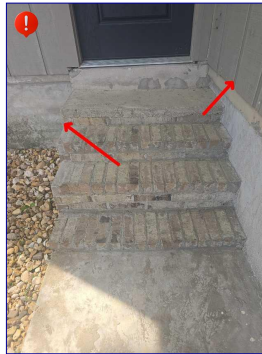
Page 26 Item: 3	Steps/Stoop	<ul style="list-style-type: none"> • There are one or more missing railings on the exterior steps. This presents a potential fall concern. Recommend a licensed contractor install proper railings.
-----------------	-------------	--

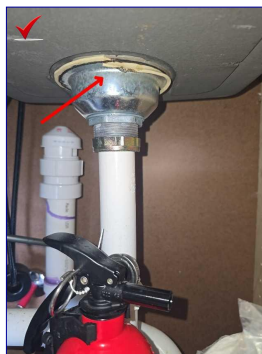
Page 41 Item: 4	Plumbing	<ul style="list-style-type: none"> • Drains in the kitchen show signs of leakage, recommend a licensed plumber repair.
-----------------	----------	---

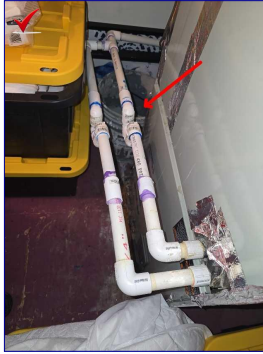
Page 64 Item: 5	Secondary Condensate Line	<ul style="list-style-type: none"> • There is no secondary condensate protection installed on the air conditioner evaporator coil drain. This is a common practice, however, we recommend a licensed HVAC contractor install a secondary protection switch to help prevent damage to the furnace in the event that the drain becomes clogged and overflows.
-----------------	---------------------------	--

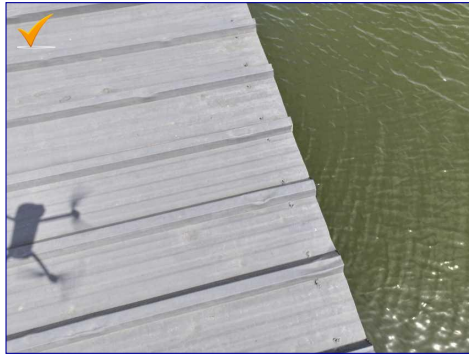
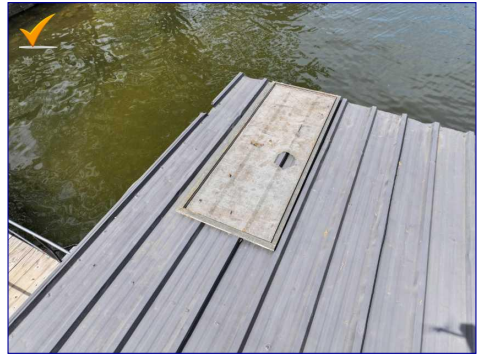
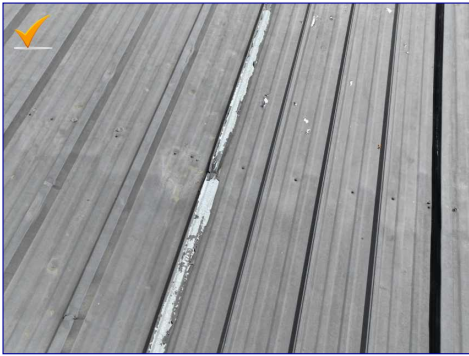
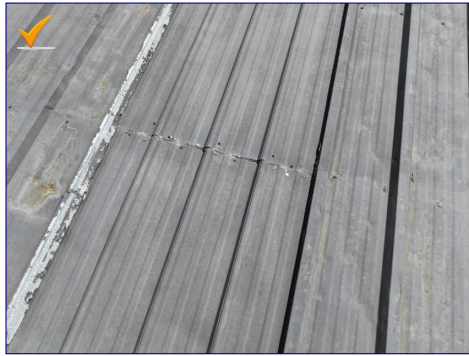
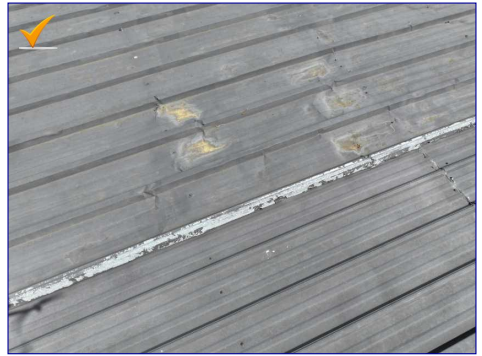
Roof View

- The boat dock roof had damage and has been patched several times. I recommend having a licensed roofer evaluate and make repairs before closing. Contact entergy shoreline for permitting.

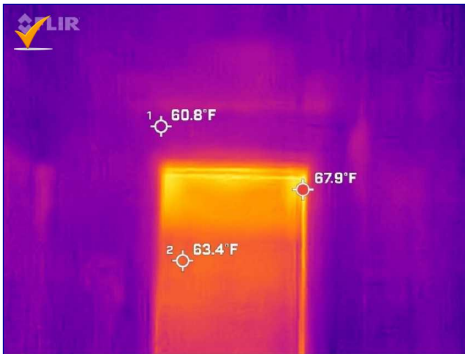
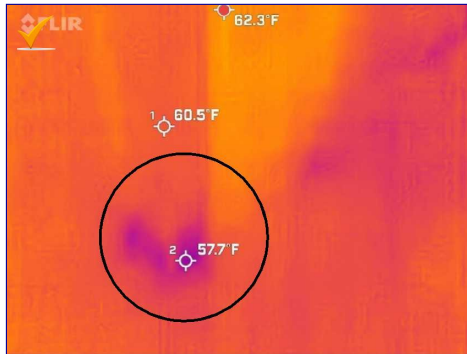
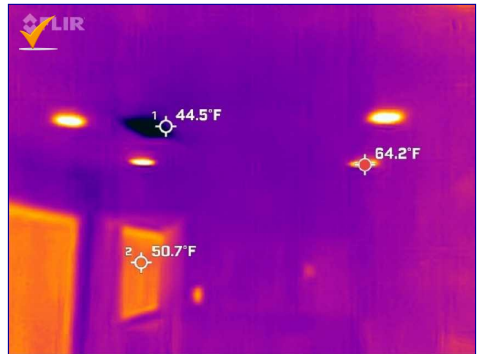
This is the moisture staining in the lower bathroom. It shows minor moisture presents. I recommend having evaluated and repaired.

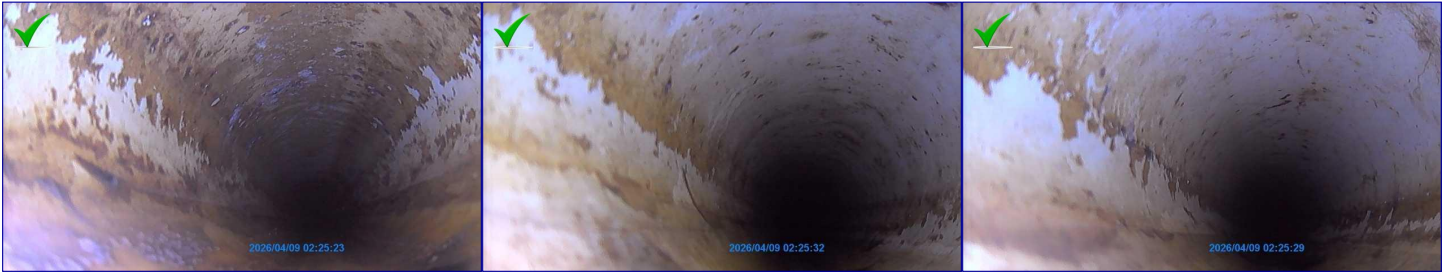
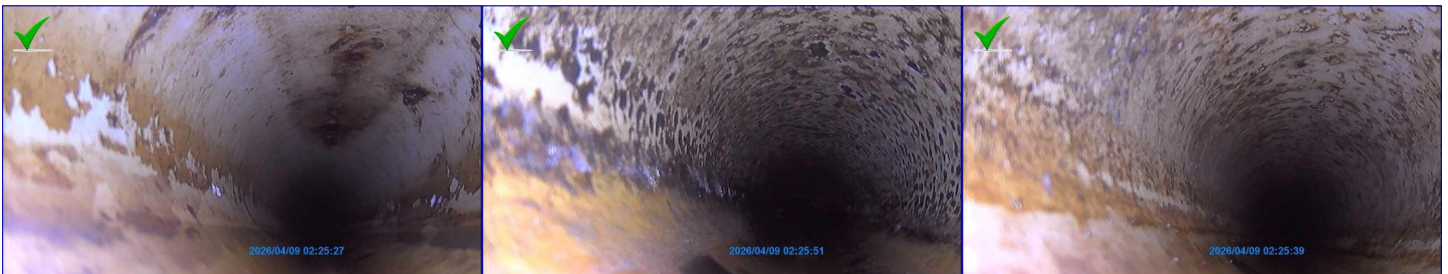
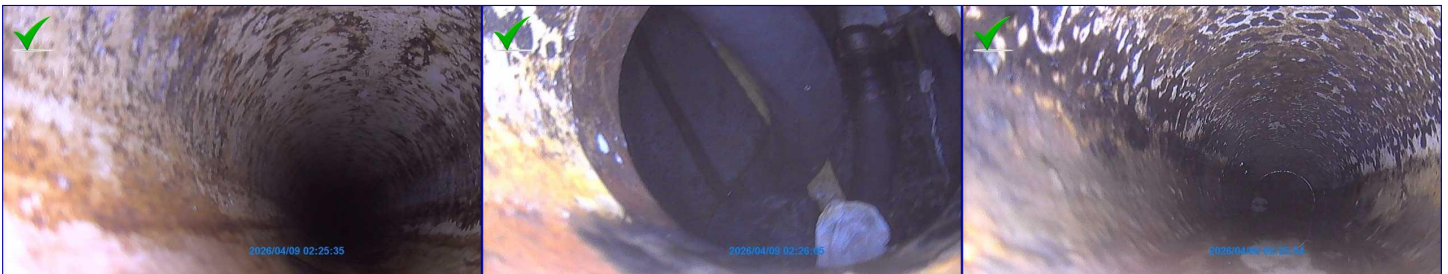
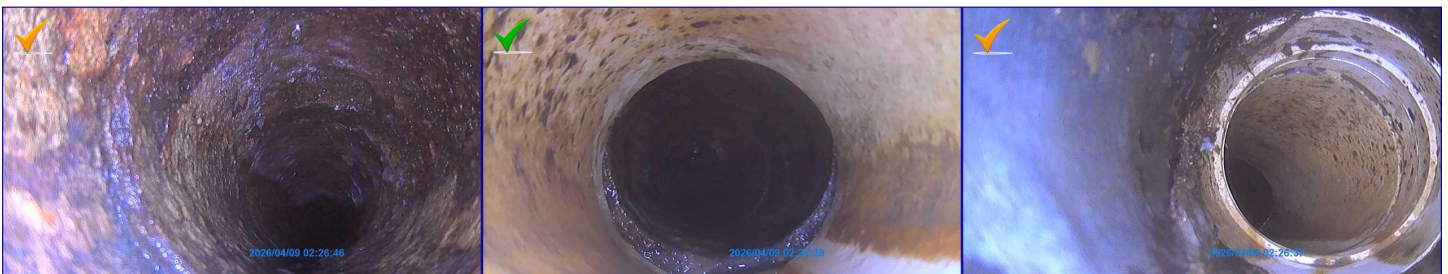
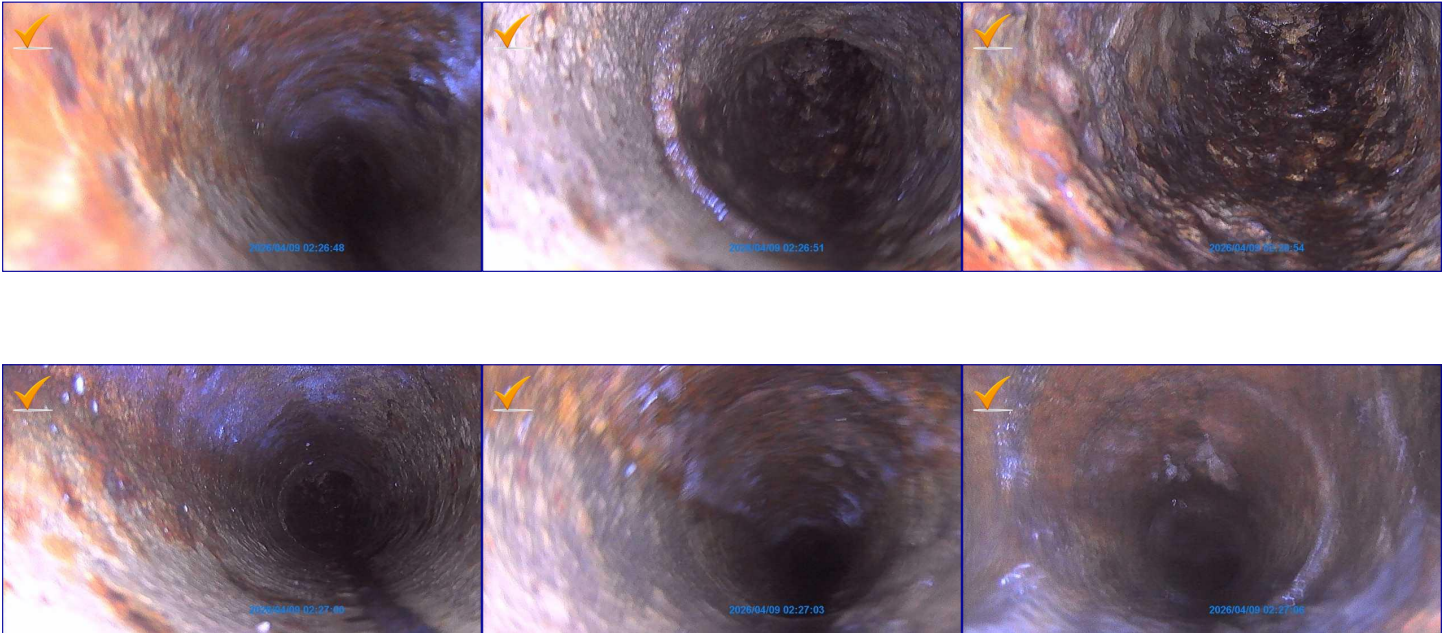
Sewer Scope Imaging (continued)

The cast iron section, however, exhibited moderate to heavy internal corrosion, scaling, and buildup along the pipe walls. In several areas, this buildup is substantial enough to reduce the effective diameter of the pipe, which can impede proper wastewater flow. Organic material and debris were observed adhering to the interior surfaces, consistent with aging cast iron piping.

It is recommended that the cast iron portion of the drain line be evaluated by a licensed plumber or sewer specialist. Cleaning (such as hydro-jetting) may provide temporary improvement; however, due to the level of corrosion and buildup observed, repair or replacement of the cast iron piping should be anticipated.

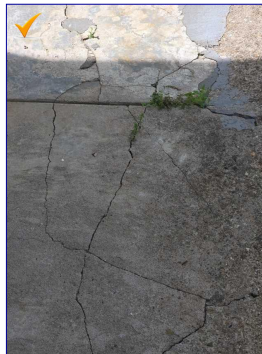
- The walkway had some typical cracking/chipping but is usable. Recommend a professional contractor seal the cracks to help prevent additional damage.

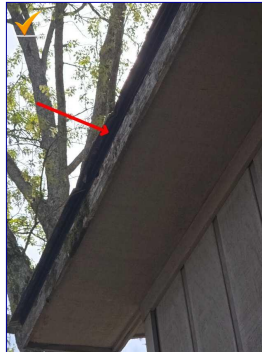
- Recommend repair/painting
- Damaged wood

- The fascia is damaged. Recommend repair by a licensed contractor.

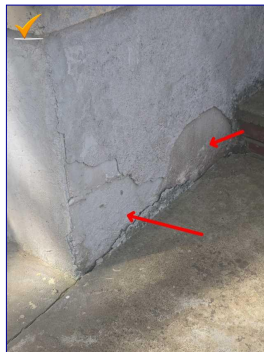
- The rear foundation wall had spalling. I recommend having evaluated and repaired by a licensed contractor.

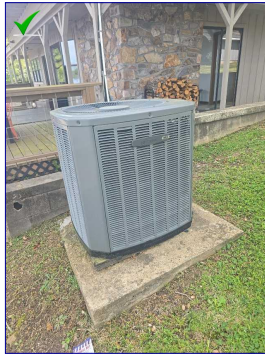
- Please note; the cooling system contains R-22 refrigerant (Freon). By EPA Standards, this Freon will be phased out starting in 2020. Accordingly, when the air conditioner requires repair to the "closed refrigerant system," the R-22 refrigerant may need to be removed. R-22 may be added to the system if available, or a retrofit option may be available. We recommend saving for repairs and replacement. Consult a licensed HVAC contractor as needed.

The air conditioner compressor/condenser.

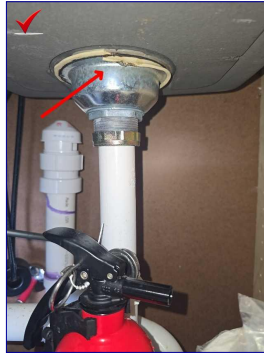
- **Drains in the kitchen show signs of leakage, recommend a licensed plumber repair.**

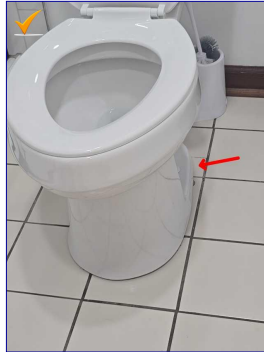
• Bowl loose: Yes

• The toilet bowl is loose. Since movement of the toilet will damage the wax ring, recommend replacing the wax ring. While the toilet is removed verify the subfloor is still in good condition. Repair as needed.

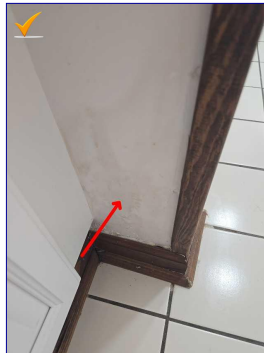
• The lower portion of the bathroom walls had signs of moisture staining. I recommend having evaluated and repaired.

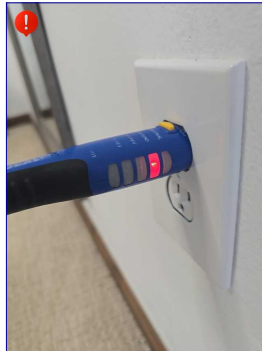
- Switches operable: Yes
- Receptacles operable: Yes
- Open ground/Reverse polarity: Yes
- Safety Hazard

- **Open ground exists at the receptacles in bedroom 1, which is a safety hazard. Recommend a licensed electrician repair.**

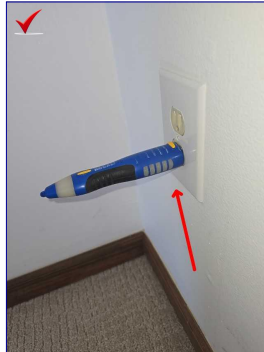
- There was a wall receptacle in the bedroom that did not work. I recommend having repaired as needed by a licensed electrician.

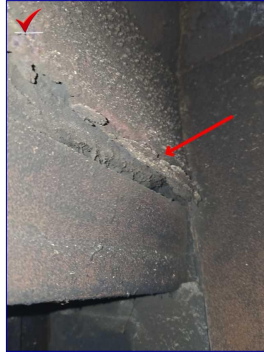
- There is soot built up in the fireplace flue. Potential safety hazard. Recommend a licensed chimney sweep clean and examine the fireplace flue.

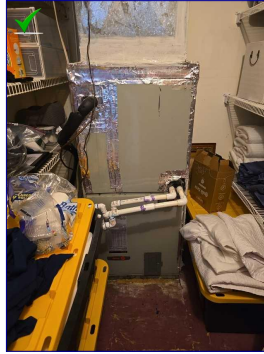
The furnace area

The filter grate door would not open due to hitting the trim. I recommend having repaired as needed for proper operation.

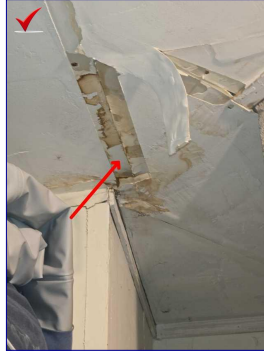
- The ceiling in the furnace closet had major moisture damage. There was no active moisture during the time of the inspection. I recommend having evaluated and repaired.

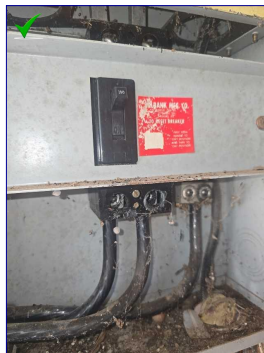
The main electrical service panel

• The electrical panel is a Challenger brand panel, which is considered obsolete and has a known history of breaker reliability concerns. Multiple deficiencies were observed, including double-tapped breakers, mixed breaker types, and disorganized wiring within the panel. Due to the age, condition, and known concerns associated with this equipment, evaluation by a licensed electrician is recommended. Panel replacement should be considered for improved safety and reliability.
