XPERT HOME INSPECTOR

**1234 Sample easy st.
Inspection Prepared For: Larry Johnson
Agent: Zubberson SallyMae - Real Estate Express**

**Date of Inspection: 10/24/2022
Year Built: 2016 Size: 2810
Weather: Sunny**

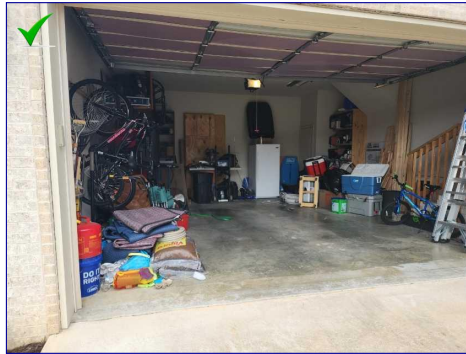
The Garage

There was a small area of garage floor with spalling. Recommend licensed contractor to repair to prevent further future damage.

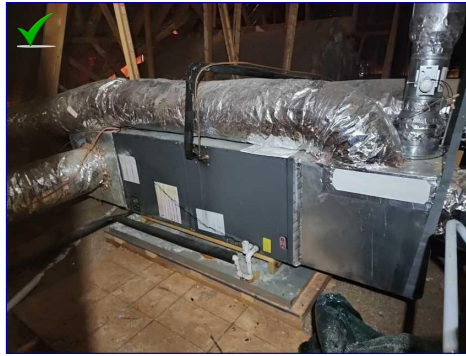
The furnace area

- Filter:
- Standard
 - Needs cleaning/replacement

The furnace filter is dirty. Recommend changing the filter per the manufacturer's recommendations.
